MISSILE 1F

INVESTIGATION REPORT

Run S1-613-14-G1

Report No. AC-62-0031

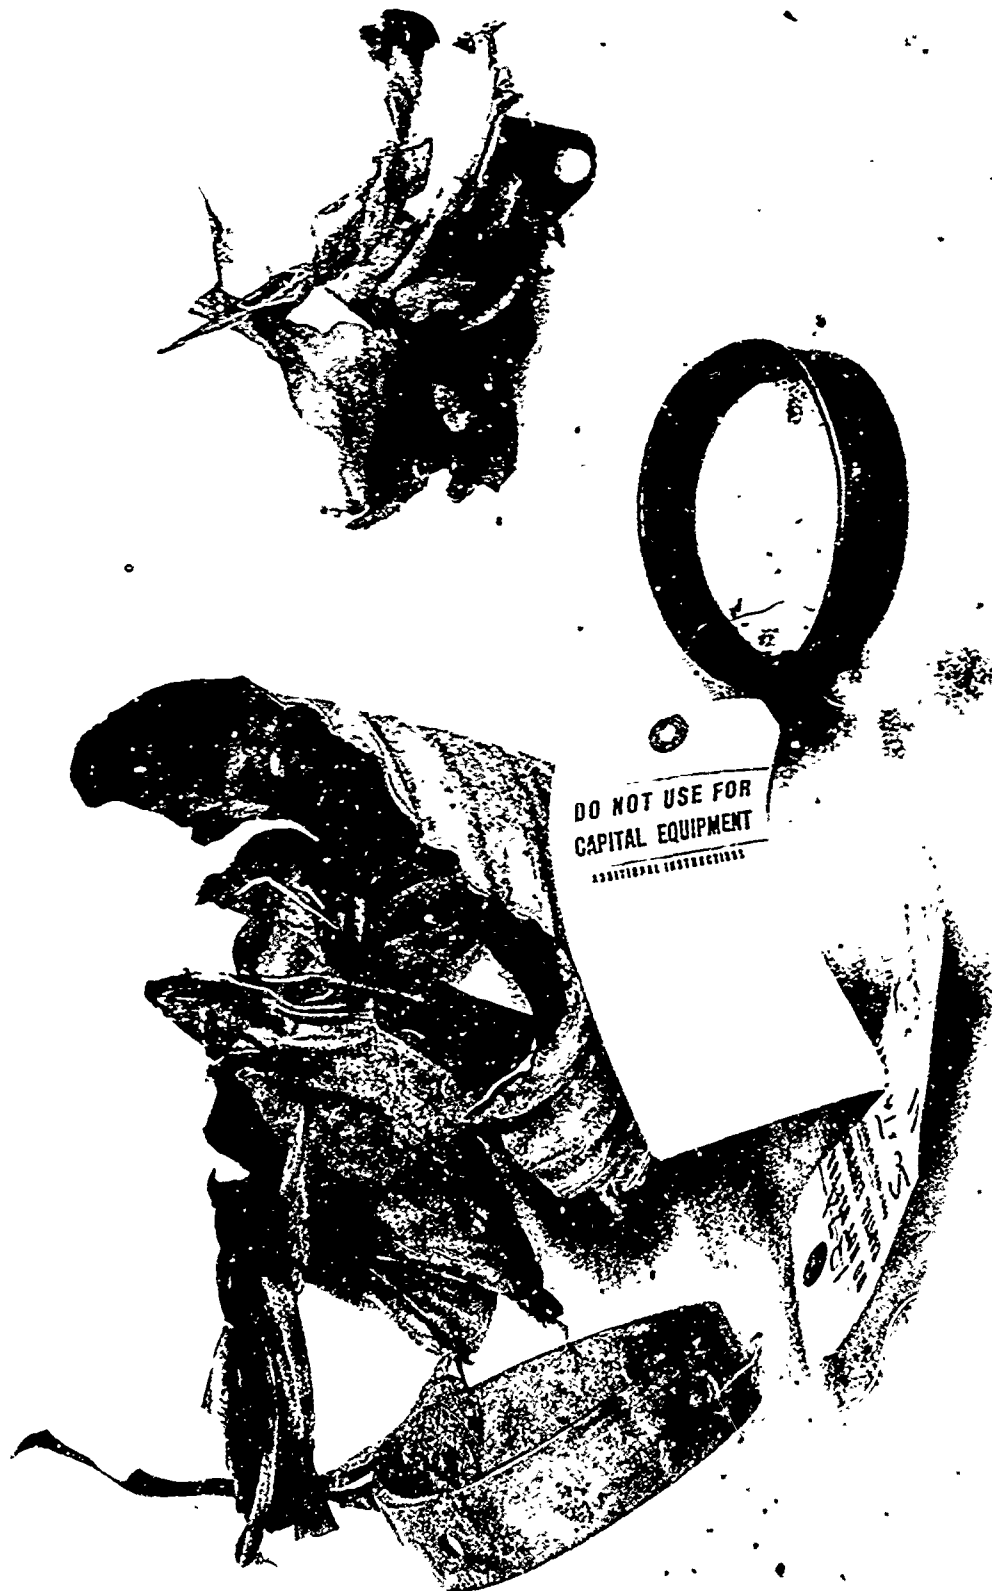
FIGURE 17 Y-DUCT BELLOWS

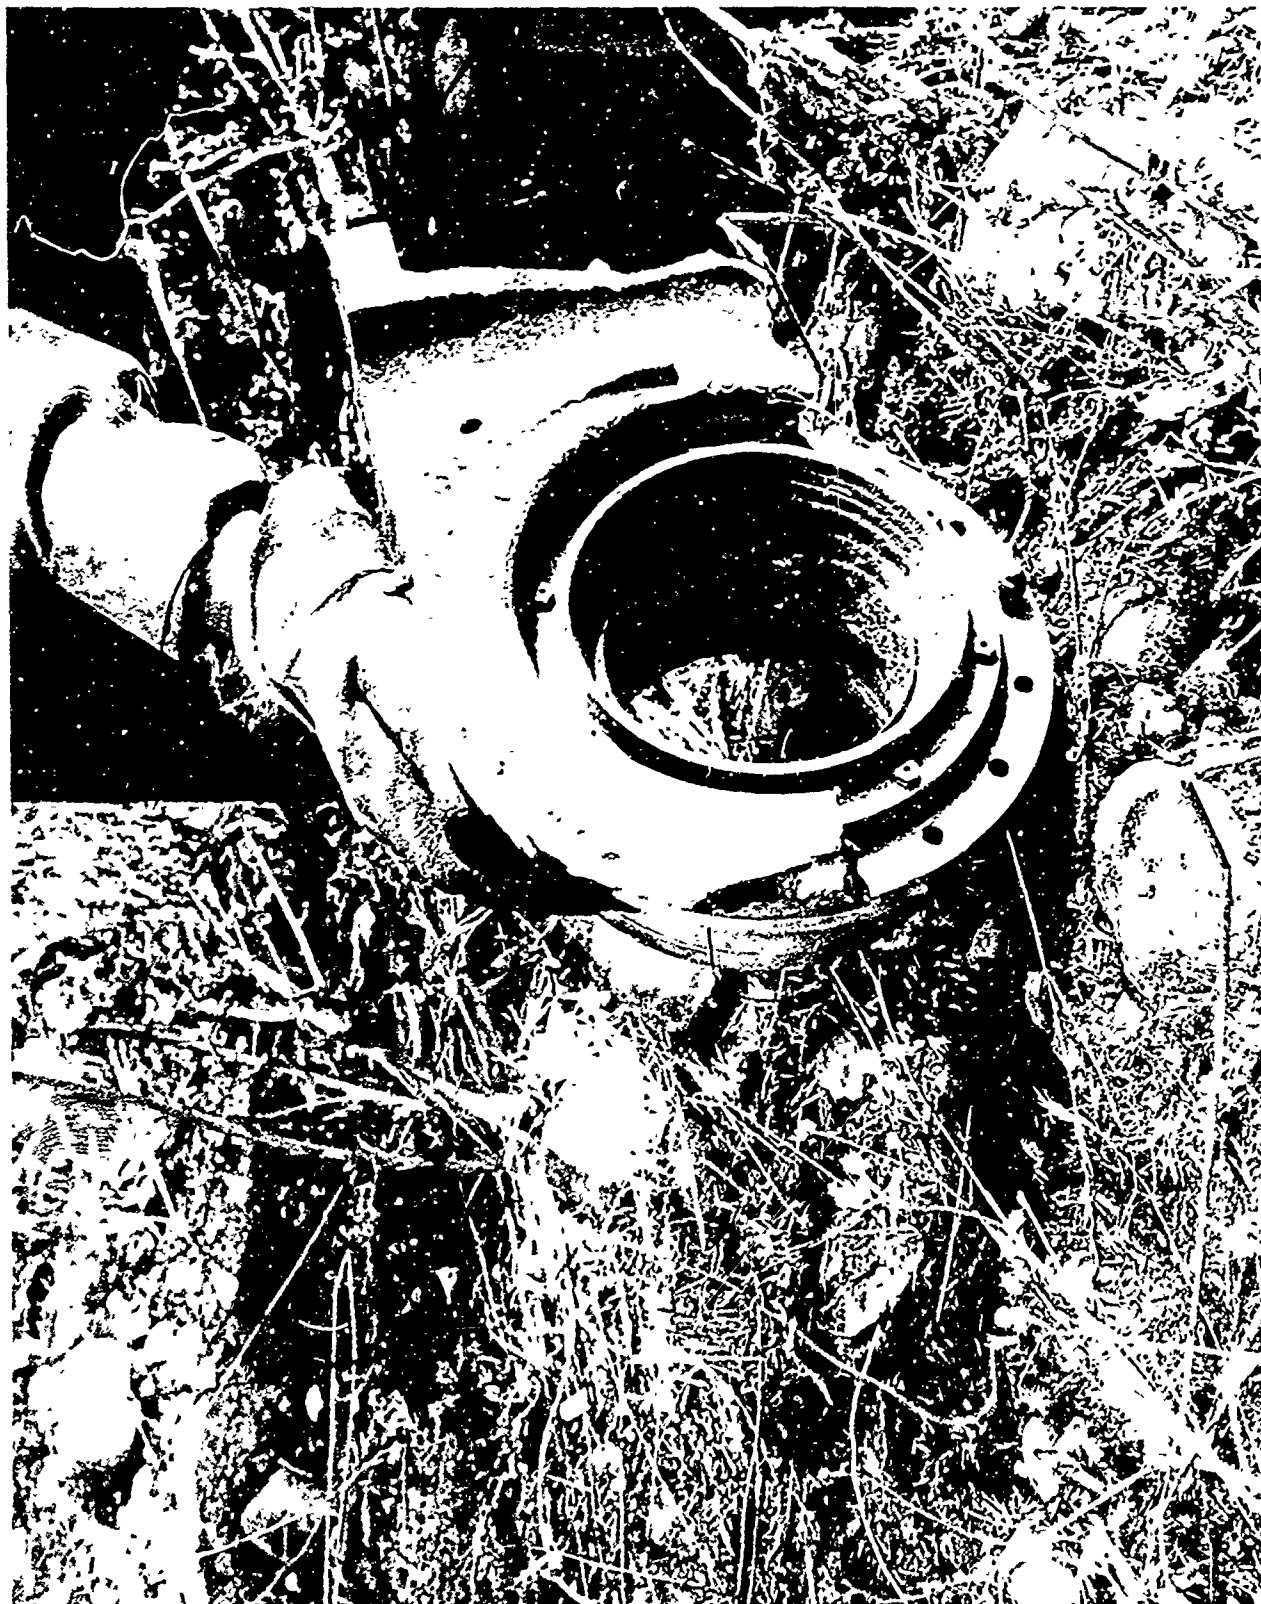
FIGURE 6.3-9

SUSTAINER LOX DUCT ADAPTER AND
PART OF BROKEN LOX PUMP VOLUTE
(Neg. No. 87912A)

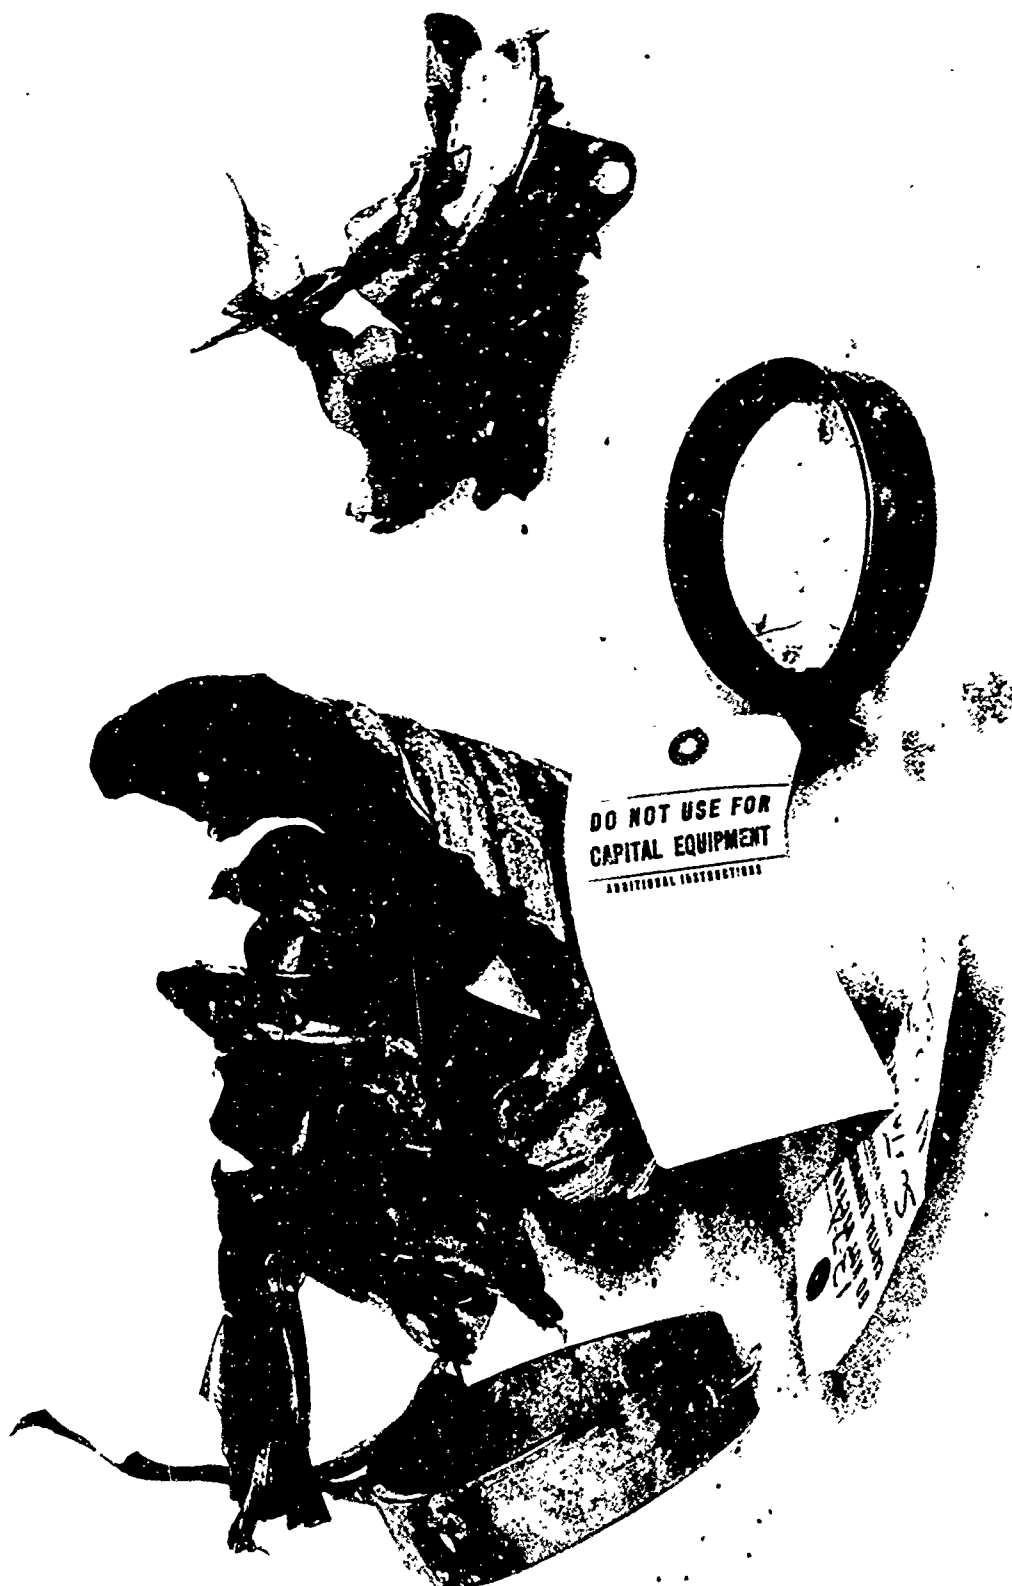
FIGURE 6.3-10

- F. Sustainer Low Pressure Ducting - The flex joint immediately upstream of the lox pump inlet flange was found severely damaged with several bellows sections flattened. All remaining portions of the lox and fuel ducting which were identified indicated severe tearing and burning.

PORTIONS OF THE SUSTAINER
LOW PRESSURE LOX DUCTING
(Neg. No. 88024A)

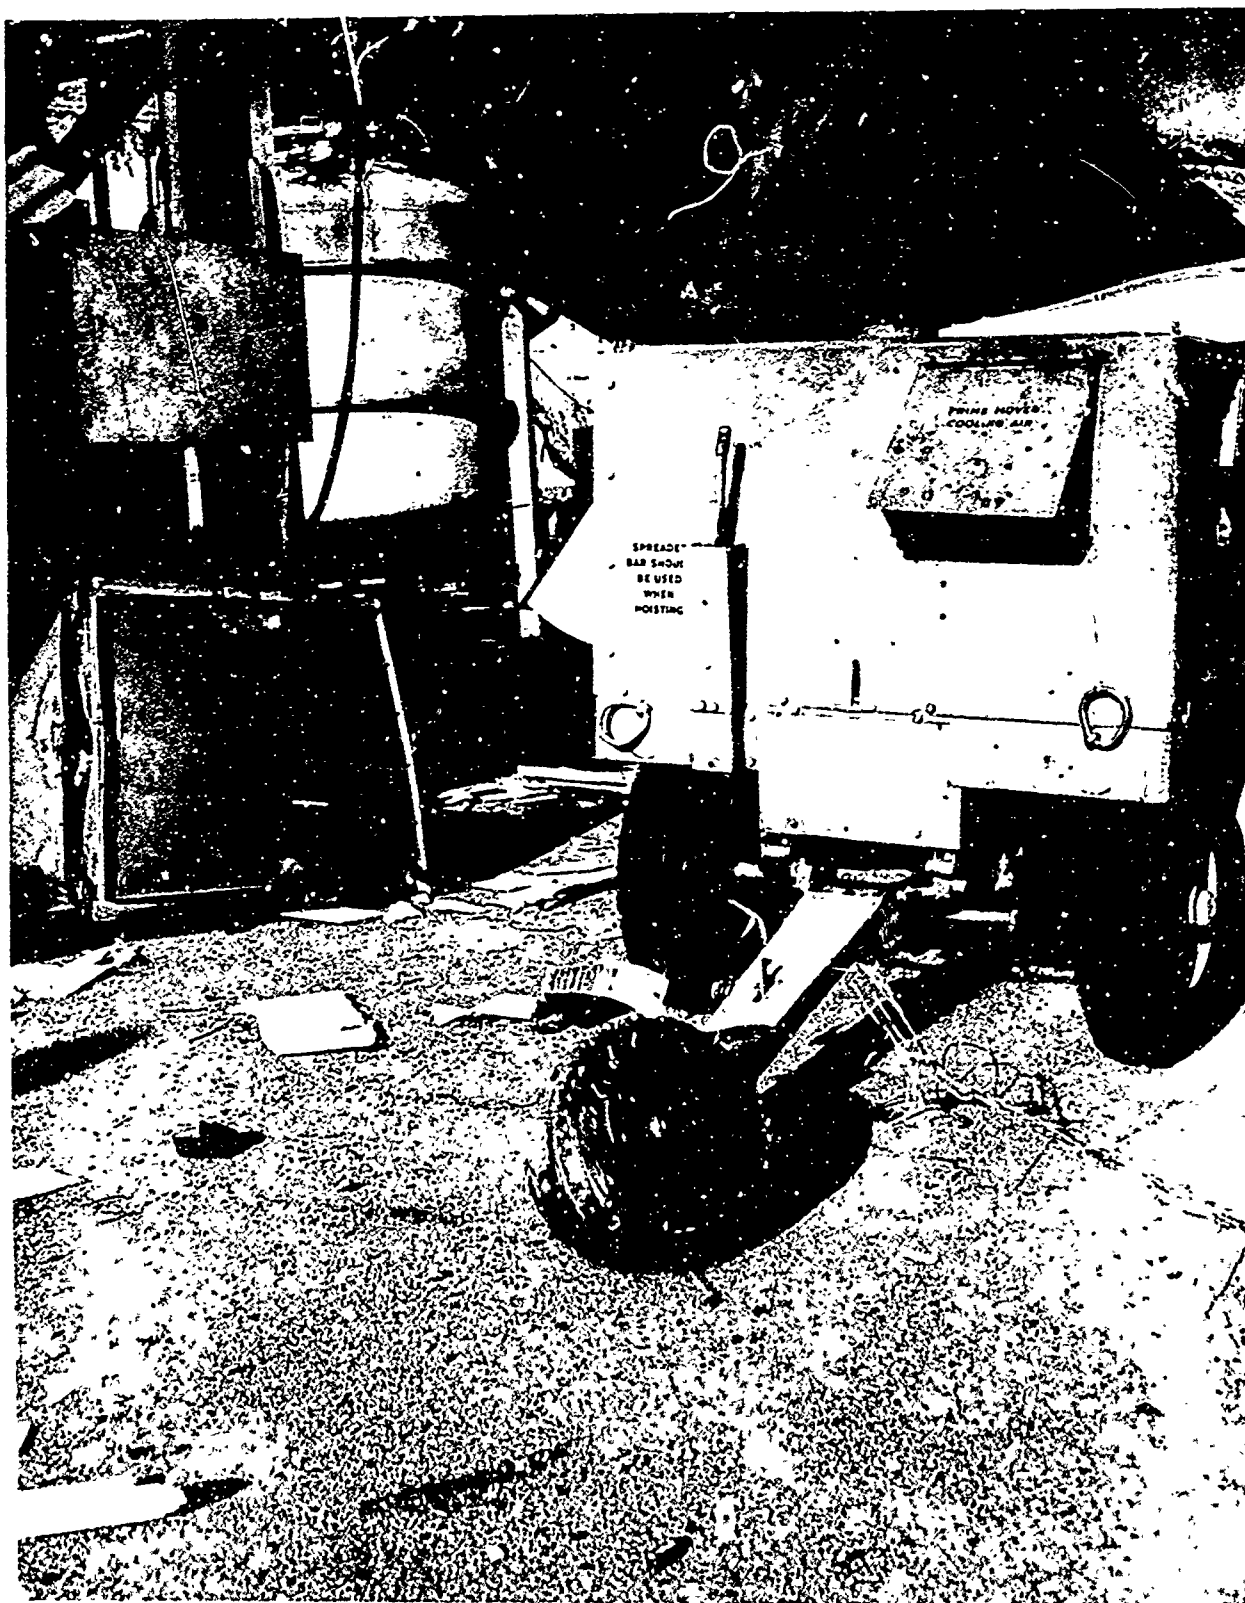
FIGURE 6.3-17

DAMAGED BOOSTER TURBINE ASSEMBLY
(Neg. No. 87921A)

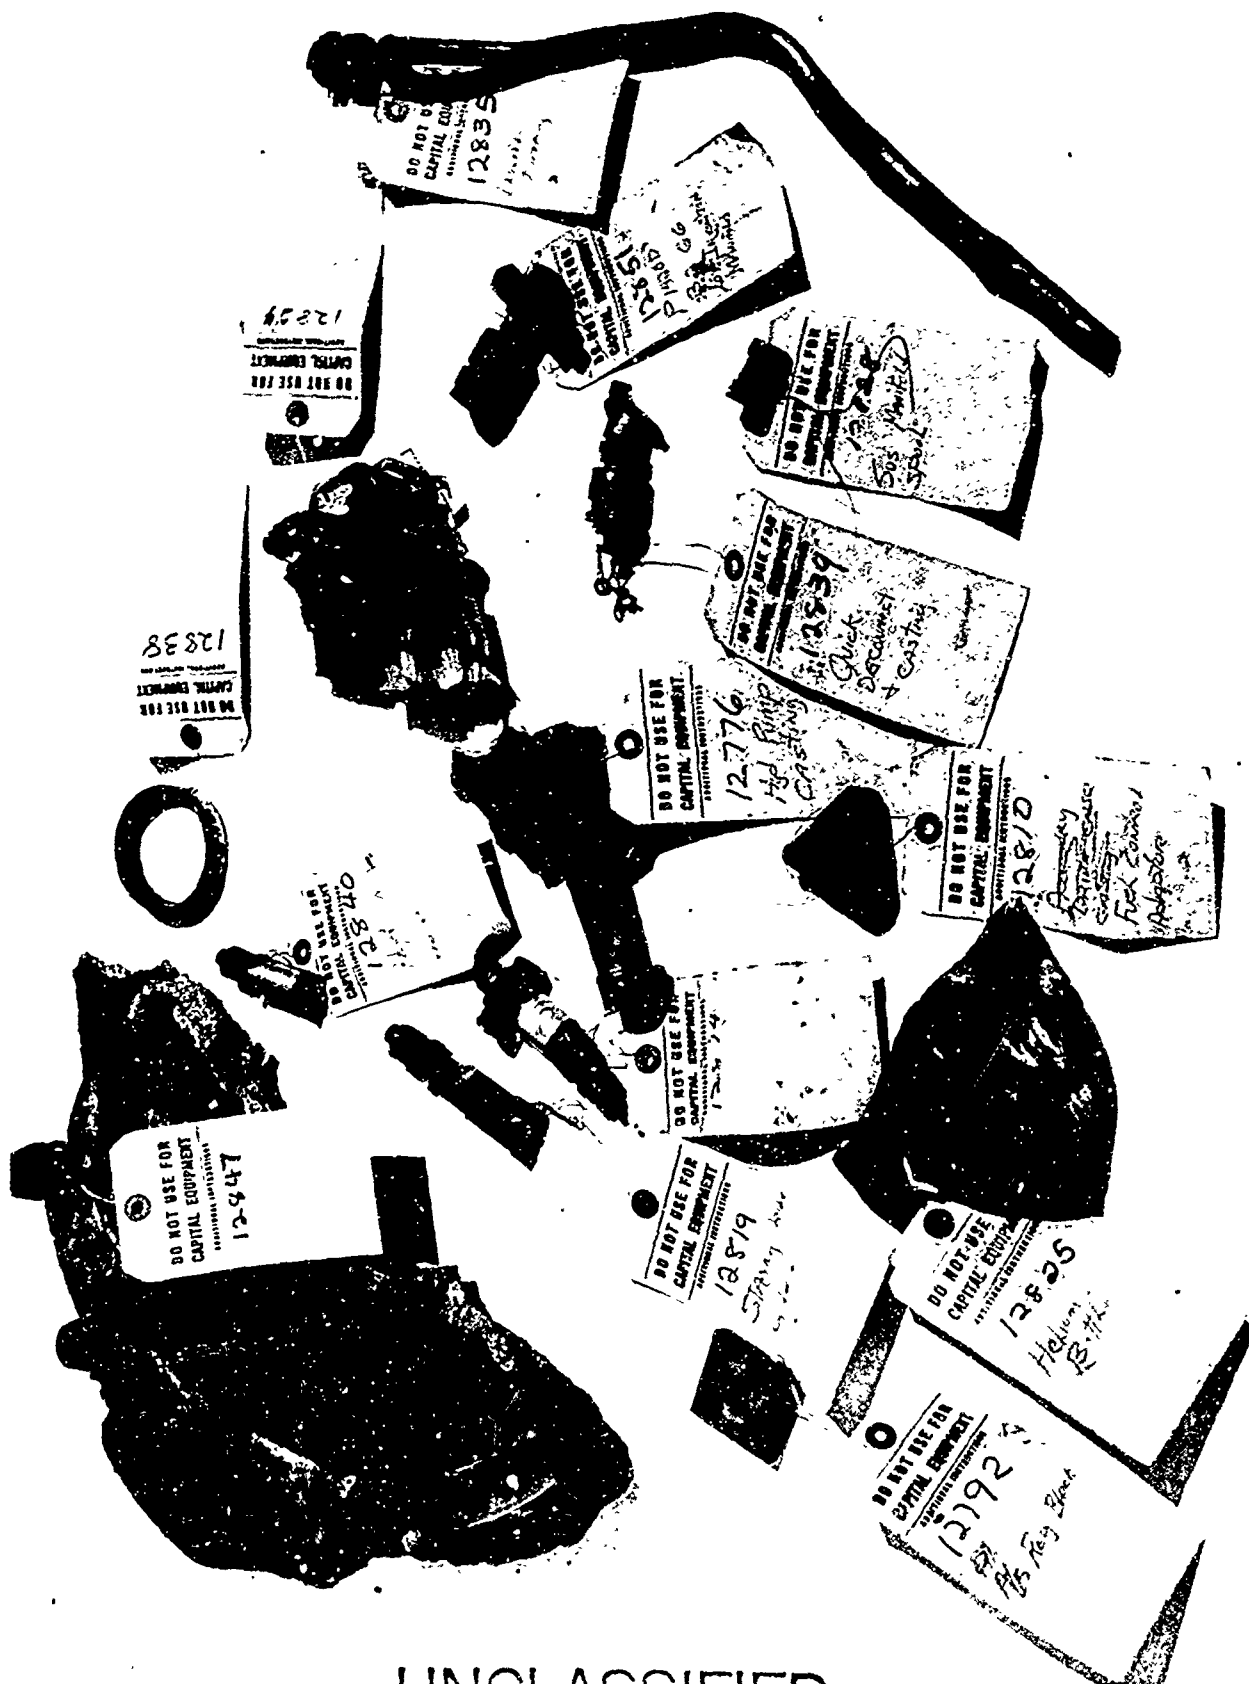
FIGURE 6.3-20

- C. Booster Engine #2 - B2 engine components were dispersed over a wide area west of the test stand or in the skim pond. All recovered hardware indicated extreme damage, due mainly to failure of B2 engine to shut down prior to missile destruction. The following major components were never located or identified: turbine exhaust heat exchanger, surge chamber, lox and fuel bootstrap lines, lox purge check valve, main lox valve, directional control valve, and ignitor fuel valve. The gimbal block, lube oil tank, main fuel valve, power package, and gas generator control assembly were all shattered into several pieces.

DAMAGED PROPULSION SYSTEM HARDWARE
--PRIMARILY B2 COMPONENTS
(Neg. No. 88315A)
